KOM EL-DIKKA

EXCAVATION AND PRESERVATION WORK PRELIMINARY REPORT, 2004/2005

Grzegorz Majcherek

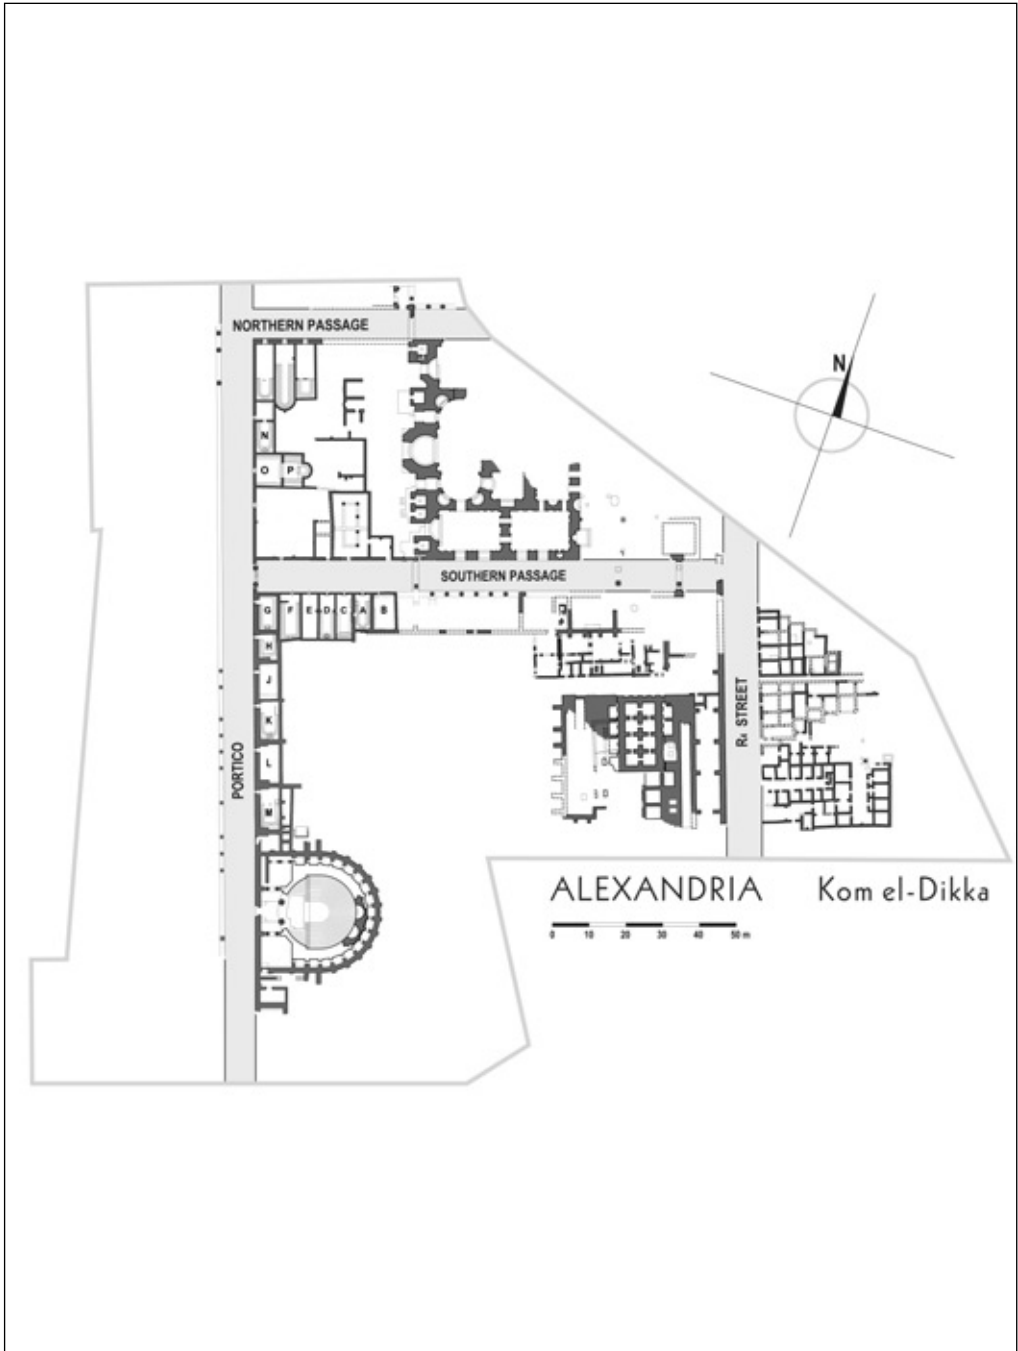
Fig. 1. Kom el-Dikka archaeological site map, state for 2005
(Drawing W. Kolčtaj, D. Tarara)

As in previous years, archaeological excavations on Kom el-Dikka were integrated with the program of the Preservation Project and covered various areas of the site [*Fig. 1*]. A major effort this year concerned the western part of the site directly behind the huge backwall of the Theatre Portico. Three previous campaigns had resulted in the discovery of a large and well-preserved complex of lecture halls of Late Roman date. The excavated area was now considerably extended to the north and east.³

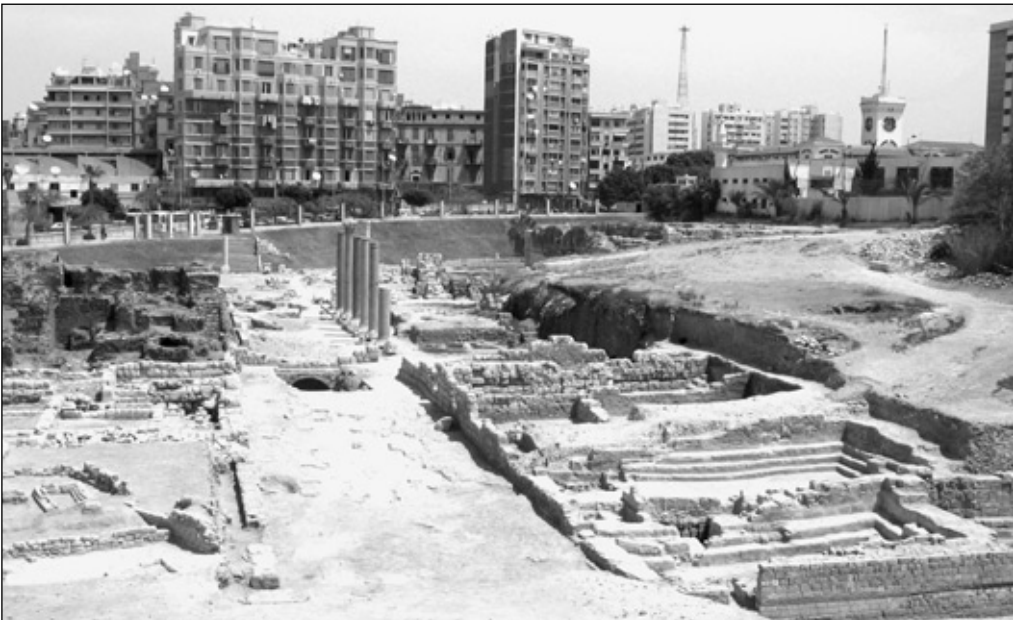
Fig. 2. Late Roman auditoria A-G
(Drawing A. Pisarzewski)

Fig. 3. Late Roman auditoria A-G. General view from the west
(Photo G. Majcherek)

Three more lecture halls (D, F, G) were cleared this season bringing the total number of these chambers to 17.⁷ They are located in the southern wing of the complex, running north of the theatre in the direction of the gate to the baths [*Figs 2-3*]. All three follow a rectangular layout.

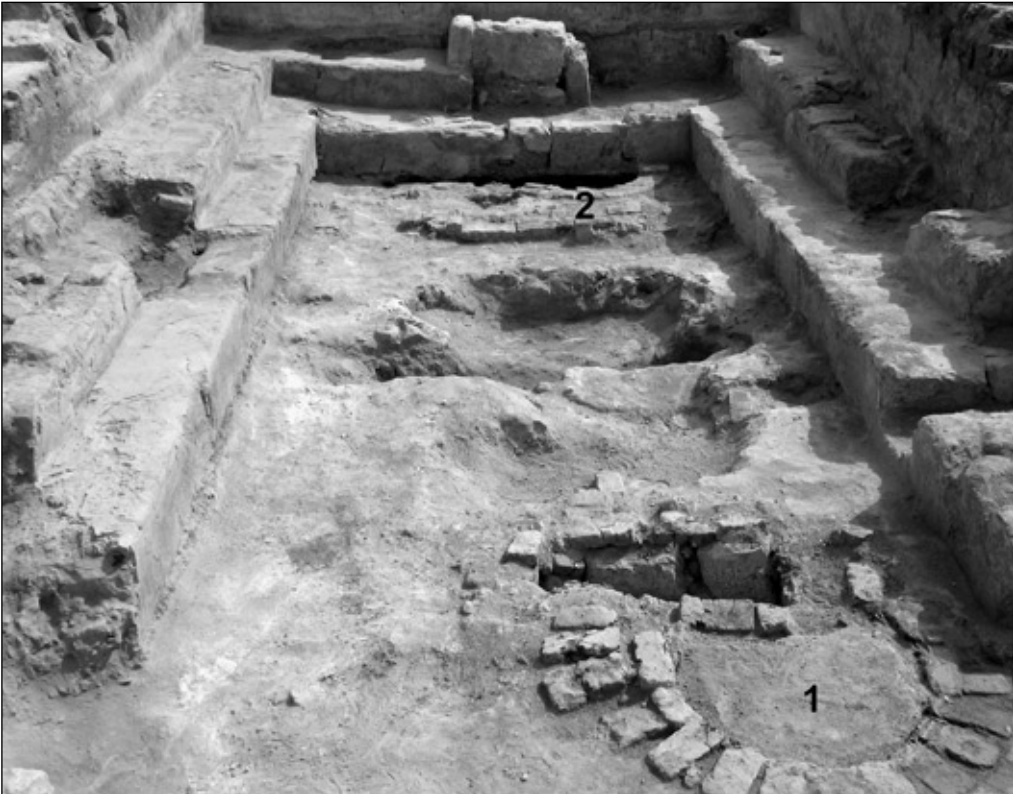
Fig. 4. Late Roman auditorium G with remains of glass furnaces cleared at floor level
(Photo G. Majcherek)

Auditorium G is located at the very corner of the southern run, next to the bath entrance [*Fig. 4*]. In similarity to the previously discovered units, it was built as a large rectangular hall (9.50 x 4.75 m), taking advantage of structures already existing in the area, i.e., the backwall of the portico. In the course of excavation it was found that its eastern wall also belonged to an earlier urban phase. Although large sections of these walls had been robbed out, it was apparent that it was huge (1.55 m thick), possibly forming part of some unknown building that had once stood behind the portico.

Like in other lecture halls located along the theatre portico, the doorways were situated in the thick backwall, invariably closer to the northern end of the auditorium. In this case, however, the doors were deprived of any structural doorjambs, being simply pierced through the thick wall instead. The floor of the auditorium was made of limestone pugging, heavily damaged by Early Islamic burials. Profiting from the scarcely preserved floor, excavations were continued in order to precise the general stratigraphy of the area. Immediately below floor level,

two small brick-made circular furnaces were cleared; one placed near the entrance and the other at the back of the hall, partly sealed by the adjacent benches. Both were apparently used as glass furnaces – glass slag was found in abundance nearby and the inner walls bore evidence of vitrification. They apparently predated the auditorium, suggesting that the area had been used as an industrial zone. These findings confirm the surprising isolation of the area behind the portico until the end of the 5th century and it is extremely difficult to reconcile an industrial establishment of this sort with the traditional function of a portico. The construction of

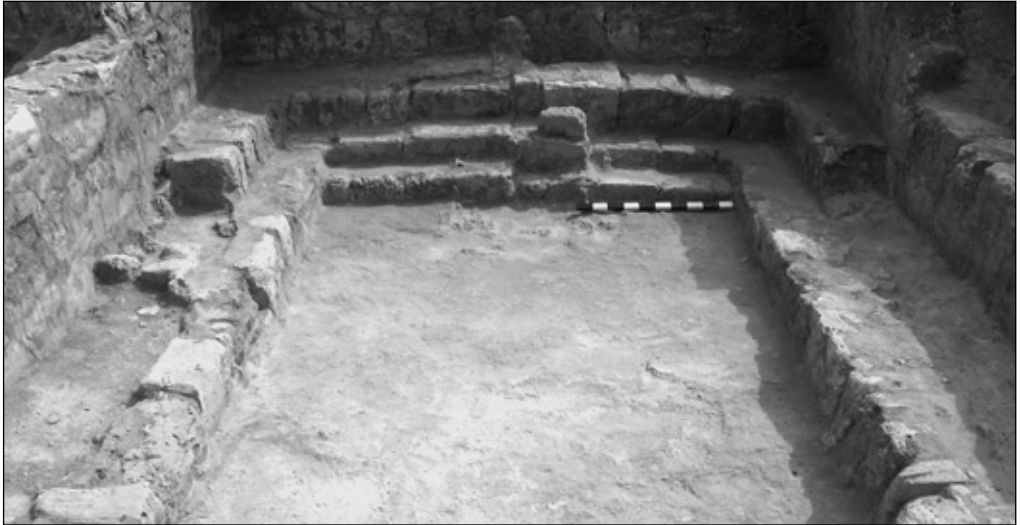
*Fig. 5. Auditorium D, view from the entrance
(Photo G. Majcherek)*

Hall D, clearly narrower than the others (7.30 x 4.25 m), was furnished with

two rows of masonry benches built along the longer sides and a raised platform (made of three benches) at the back [Fig. 5]. The monumental seat encountered in other halls was not preserved, but clearly visible imprints and leftover plastering pointed to the existence of steps originally leading up to it. As a rule, the benches were made of a single row of large blocks, but in several sections larger blocks cut from the brick walls of abandoned structures, most probably the bathhouse or cisterns, were reused – a phenomenon previously noted also in other constructions of the Late Roman age. Plastering, which was the rule on the benches, covered and evened out all the irregularities. Interestingly enough, the auditorium is not entered directly from the bath passage and it is separated by a continuous wall from another chamber which is. It is not yet clear whether this latter room was an anteroom from the start or was partitioned off at a later date.

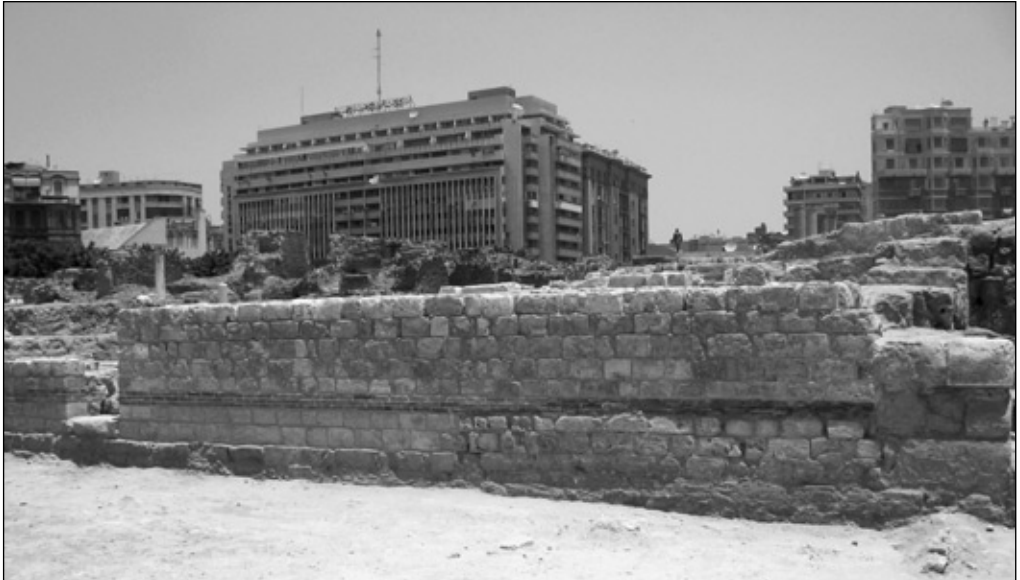
*Fig. 7. Restored section G of the portico backwall
(Photo G. Majcherek)*

The last remaining section of the portico wall (section G), some 12 m long, was thoroughly restored [Fig. 7]. The core of the wall, visible where most of the facing

had long been lost, was duly cleaned and stabilized with lime mortar filling all the cracks and crevices. The facing was rebuilt using mostly blocks retrieved from nearby graves and retaining their original shape and size. It was apparent that these blocks had been robbed from the backwall in medieval times to serve as handy building material for the nearby tombs. The facing was rebuilt in places up to 1.80 m above the portico pavement. The missing brick lacing was restored with new bricks cut to required dimensions. Following a general conservation principle established for the site, the newly restored wall facing, albeit done in original stones, was clearly separated from the extant original masonry with a layer of bitumen tarpaper and additionally with two slightly recessed courses of new blocks. Restoration in this section of the backwall involved also

a rebuilding of the original entrance. Both door jambs were structured in small blocks, following the original technique.

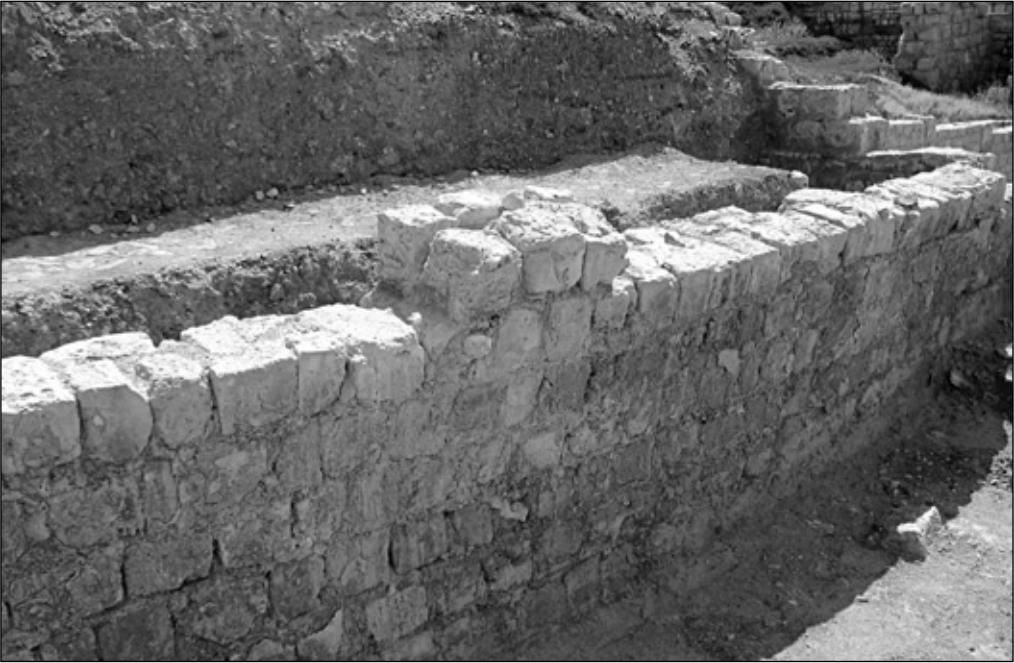
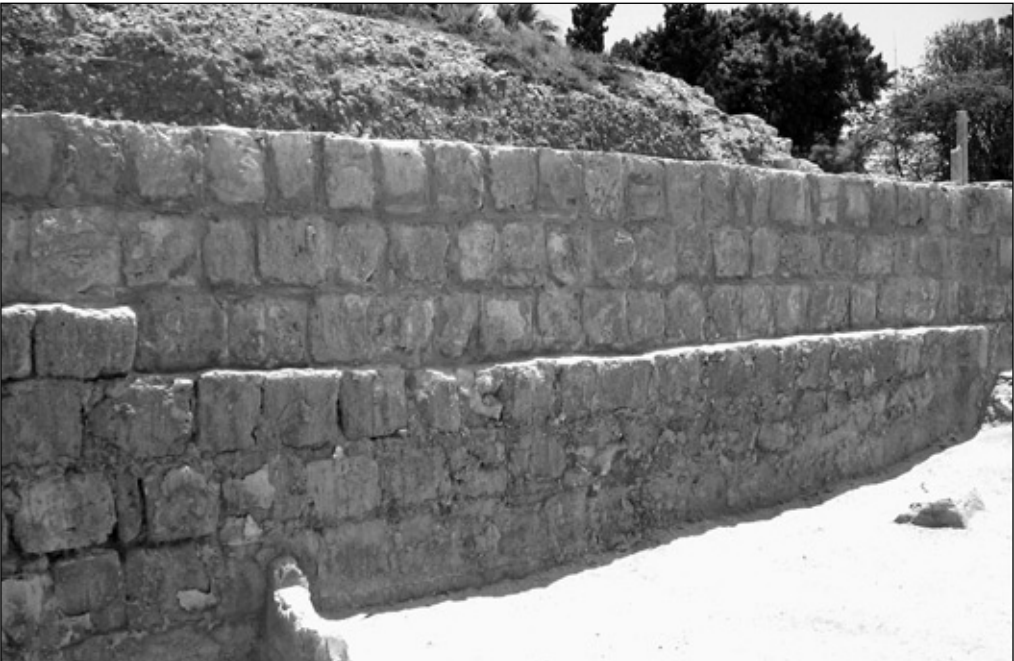
*Fig. 8. Auditorium L, eastern wall before (top) and after consolidation
(Photo G. Majcherek)*

Auditorium L posed yet another problem. It was ascertained that the area behind the wall had been abandoned already in late antiquity, becoming a dumping ground for city waste. The process of accumulation was so rapid that ancient builders had to deal with the heavy load exerted by the growing dump. Although built of large ashlars, the east wall constructed in the 6th century had not sustained the combined load of the dump and had leaned out substantially, requiring intervention [*Fig. 8, top*]. Following photographic documentation of the most endangered section, all the stones in the topmost three courses of masonry were duly marked and the section carefully dismantled. The whole wall was then reassembled [*Fig. 8, bottom*]. In order to assure stability, some badly eroded stones were replaced with new blocks.

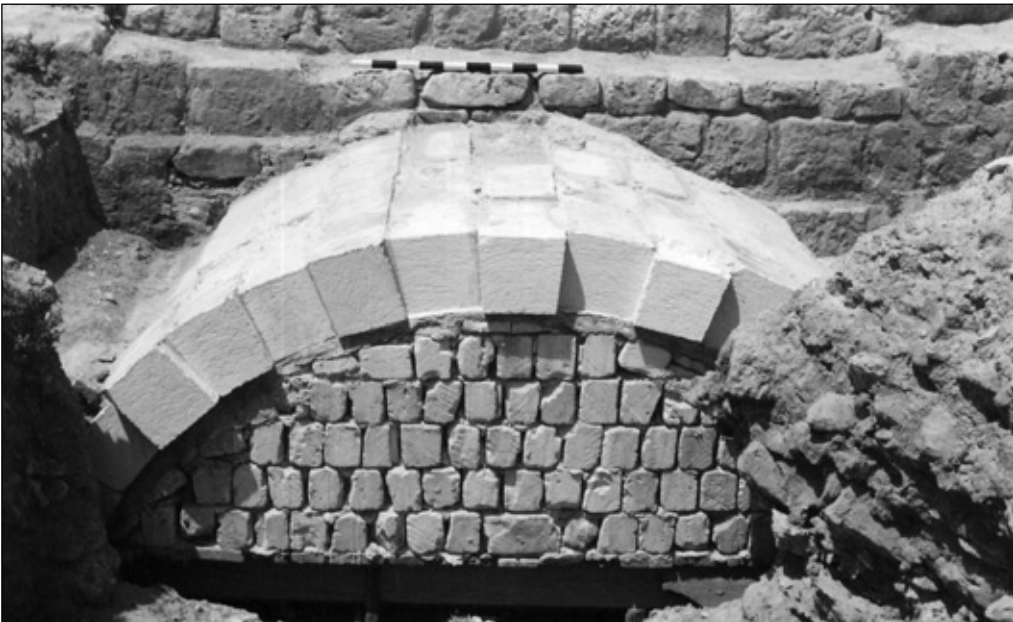
*Fig. 10. Vault next to the western gate after restoration
(Photo G. Majcherek)*

Work was also continued in the area next to the western gate of the bath complex, where one of the adjacent vaults was consolidated and restored [*Fig. 10*].

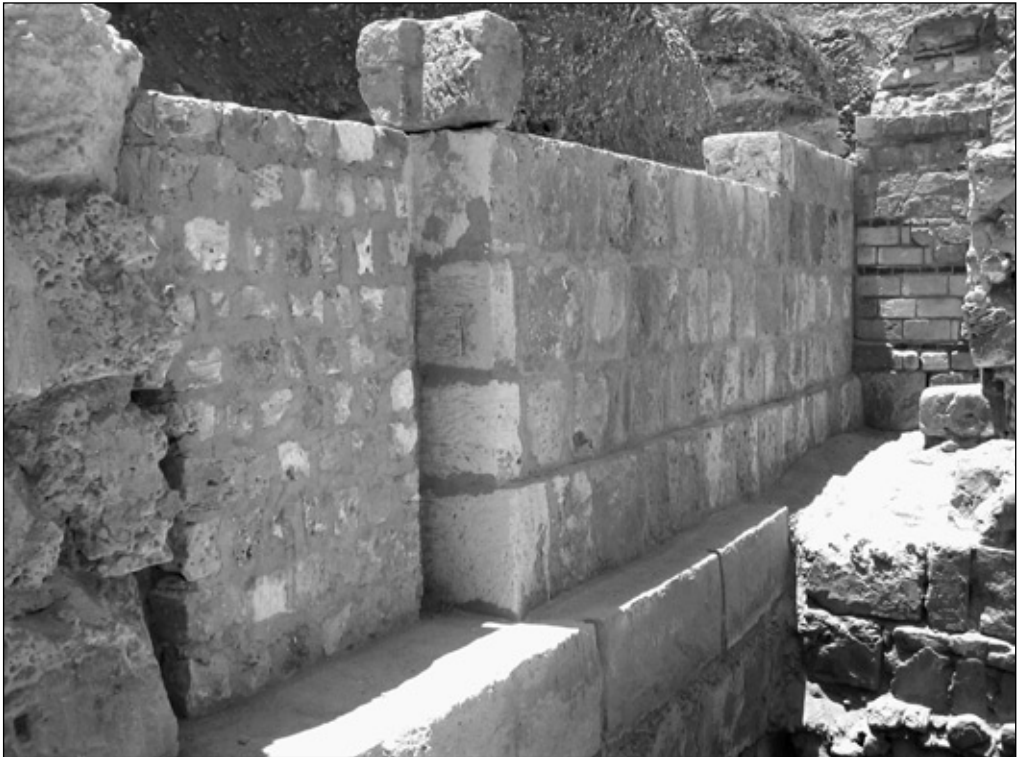
*Fig. 11. Early Roman house F, restored southern wall
(Photo G. Majcherek)*

In area F, large fragments of two houses (FA and FB) of Early Roman date had been explored already in the 1990s.⁹ They were built along a small E-W side street. Some fragments of these structures were already subject to conservation procedures in the previous seasons.¹⁰ This year, an operation for restoring the southern elevation of these houses was initiated. The facade wall (some 0.50 m thick and 25 m long) was rather poorly preserved. Large sections of it were dismantled down to the foundation

level. Only at the eastern and western ends, the wall stood to a substantial height of approximately 3-5 courses of ashlar. The biggest problem faced by conservators was the shortage of proper stones suitable for reconstruction. Using seasoned stones stored at the site, as well as loose blocks found during excavations finally solved the issue. All the blocks were carefully chosen with regard to their quality and dimensions in order to meet restoration requirements. The wall was finally rebuilt

to a height of 4-5 courses (approx. 1.60-1.85 m). The doors were structured in the required locations according to the original archaeological evidence. Since the wall was designed also to serve as a sustaining wall for the planned escarpment along the cisterns, it was decided to block the doors in order to create a continuous barrier and to enhance its structural strength. The doors were blocked with smaller stones in an attempt to separate the original structure of the house from modern additions necessitated by the planned site exhibition [Fig. 11]. An additional wall dividing rooms F9 and F10, structured in pillar technique, was also thoroughly rebuilt.
